Debris/Ice/TPS Assessment and Integrated Photographic Analysis of Shuttle Mission STS-82

Technical Memorandum 112647

April 1997

**DEBRIS/ICE/TPS ASSESSMENT
AND
INTEGRATED PHOTOGRAPHIC ANALYSIS
OF
SHUTTLE MISSION STS-82**

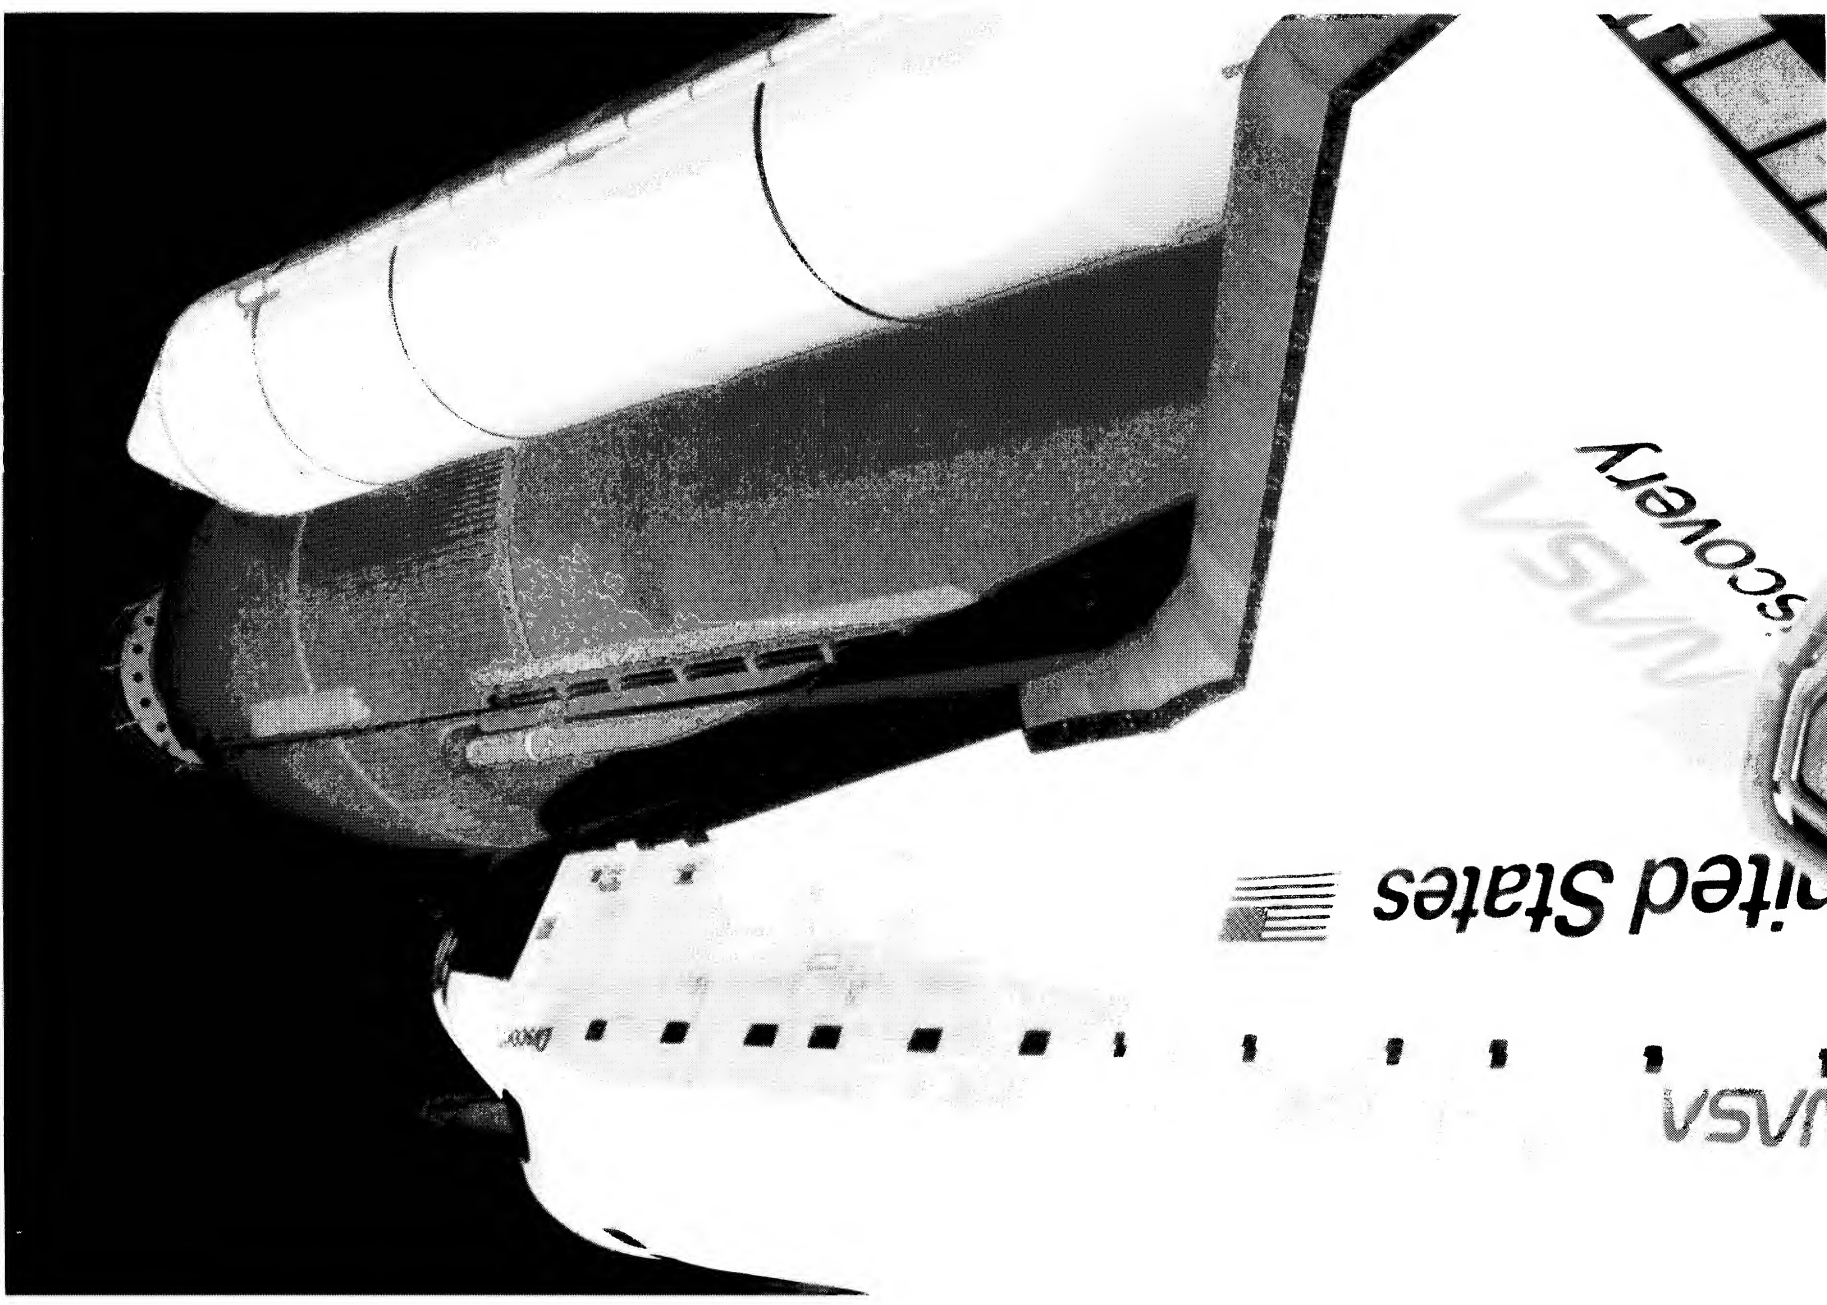
Photo 3: STS-82 Cryoload for Flight

OV-103 Discovery (22nd flight), ET-81 (LWT 74), BI-085 SRB's

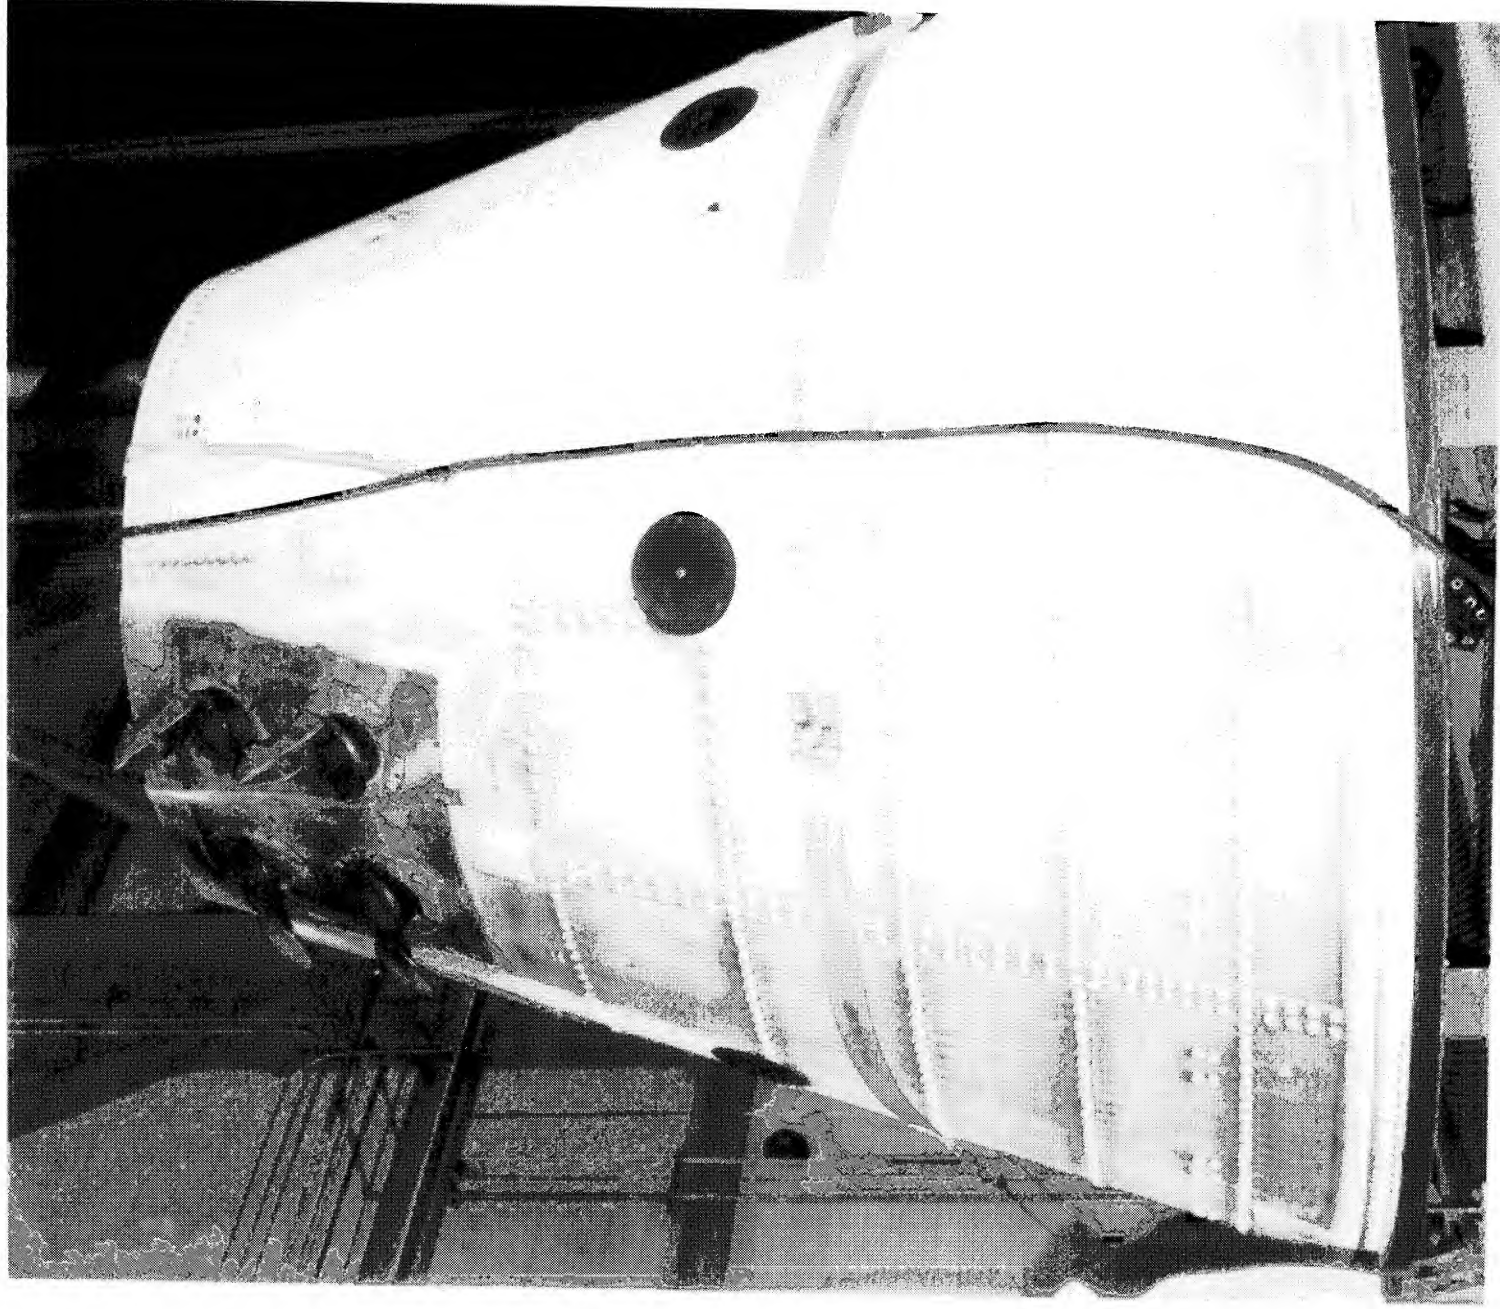
Photo 10: LH Frustum

The Solid Rocket Boosters were inspected at Hanger AF after retrieval. Both frustums were in excellent condition. No MSA-2 debonds over acreage or fasteners were detected. All eight BSM aero heat shield covers had locked in the fully opened position, though the two outboard cover attach rings on the left frustum had been bent by parachute riser entanglement. There were no clear indications of aft skirt stud hole breaching or stud hang-ups on this flight (review of launch films support this finding). The holddown post Debris Containment Systems (DCS) plungers were seated and appeared to have functioned normally with the exception of HDP#4, where the plunger seating was obstructed by the frangible nut halves. This condition may have been the result of splashdown. Tape inadvertently left on the LH SRB aft booster just aft of the IEA during pre-launch processing was mostly intact.

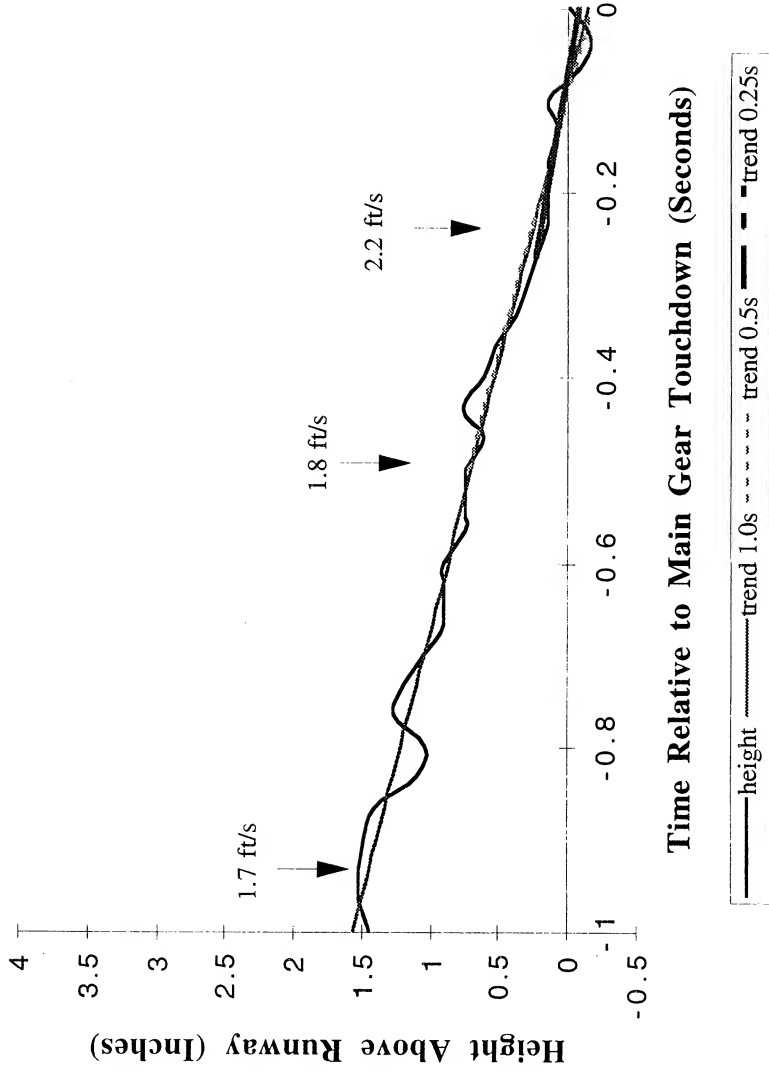
Figure 2.6.1 (A) Main Gear Height Versus Time Prior To Touchdown (Video)

The measured main gear sink rate values were found to be below the maximum allowable values of 9.6 ft/sec for a 211,000 lb. vehicle and 6.0 ft/sec for a 240,000 lb. vehicle (the landing weight of the STS-82 Orbiter was reported to be 213,710 lb.). The sink rate measurements for STS-82 are given in Table 2.6.1. In Figure 2.6.1(A), and 2.6.1(B), the trend of the measured data points for the image data is illustrated.
